**DEPARTMENT OF TRANSPORTATION**

**OBG # TRIAL ASSEMBLY YARD (8AE)**

## WELDING INSPECTION REPORT

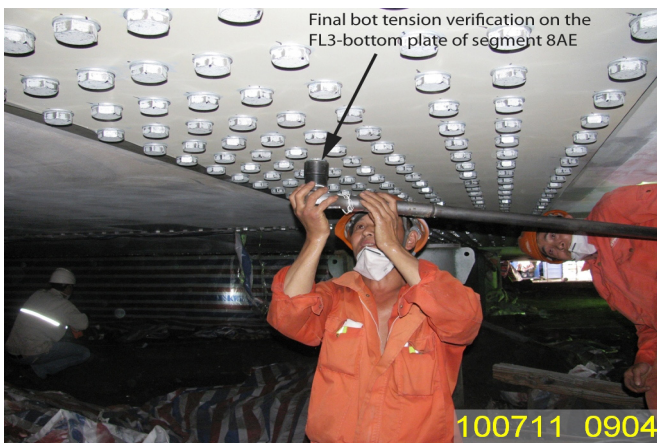
This QA inspector witnessed the final bolt tension verification on the FL3 – Web plate to bottom plate of segment 8AE. The torque wrench S/N was X02-666 and X0-747. The QA inspector witnessed 10% of the bolts on a random basis and found the tensioning of the bolts appeared to be in general compliance. The panel point and bolt size designations were as follows:

PP 62 to PP 64:

M24 X 60 – DHGM 240014 – 567 NM

M24 X 65 – DHGM 240013 – 540 NM

M24 X 70 – DHGM 240075 – 1480 NM

For additional information please reference the pictures below:
